Upgrading a Leak Trough-Line Mk.2

Neville Roberts

There have been many companies that have offered an upgrade service for the legendary Leak Trough-Line FM tuner in the past, but numbers are dwindling. However, quite a lot can be achieved by an amateur enthusiast without the use of specialised test equipment. Neville Roberts describes his approach to doing it yourself...

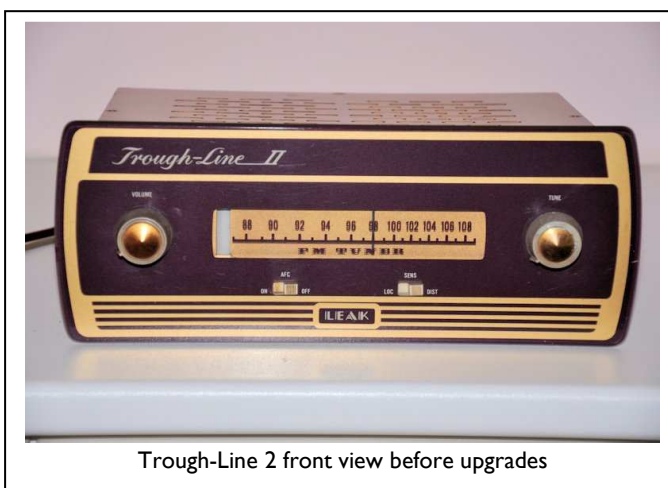
Trough-Line 2 front view before upgrades

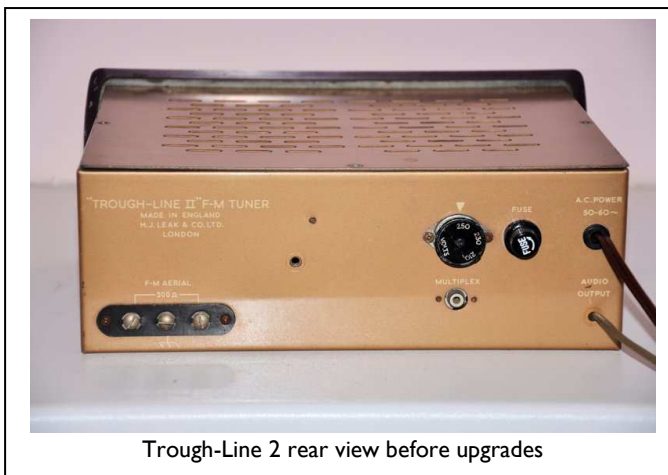
Trough-Line 2 rear view before upgrades

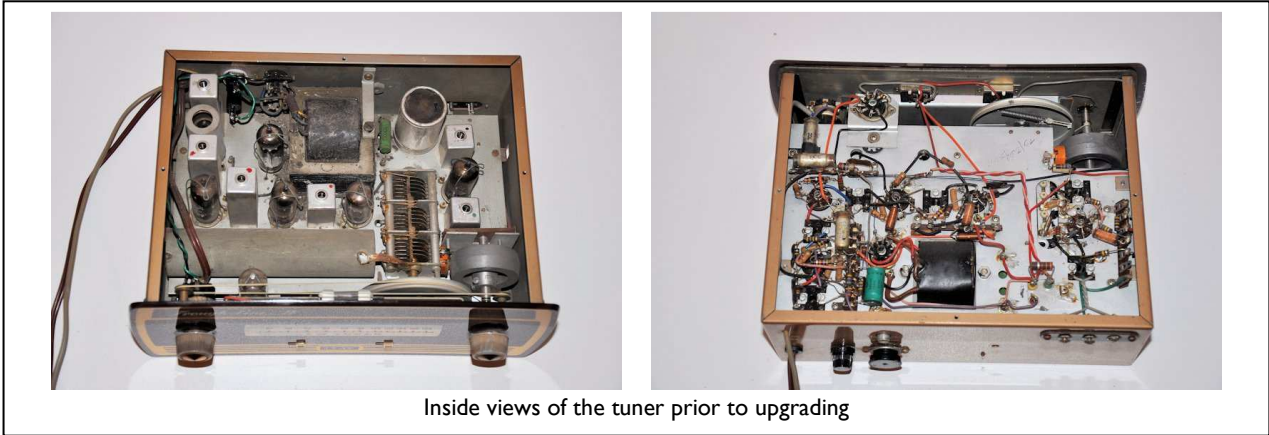
Inside views of the tuner prior to upgrading

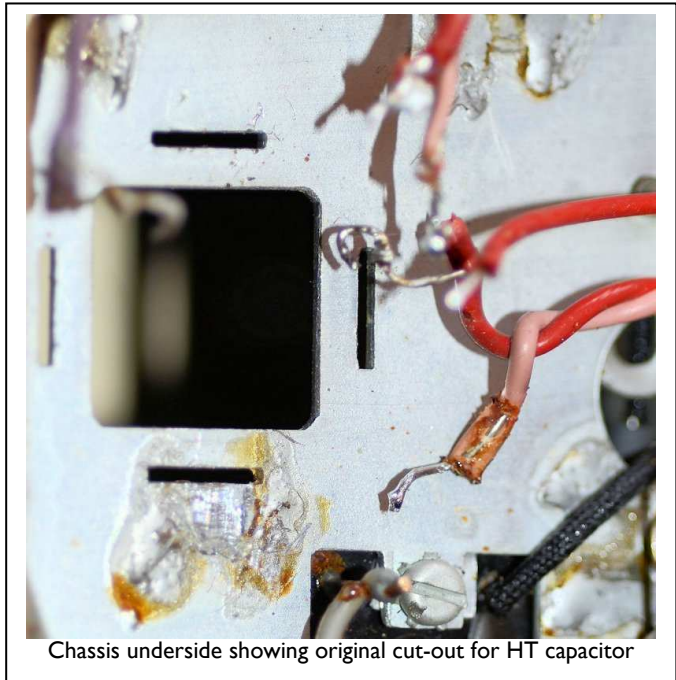
Chassis underside showing original cut-out for HT capacitor

To replace the triple can, first unsolder the connections to the three solder tags. Then untwist three of the four retaining tags on the can. The fourth one is soldered to the chassis and I found the easiest way to remove it was to tap a thin screwdriver

underneath it and prise it away - the capacitor then comes away easily. Using a junior hacksaw blade, I enlarged the hole by cutting away the bit of metal on the top and bottom slots. The Mundorf then fitted nicely in the space and the earth tag was soldered onto the chassis in the same place as the old can with my iron turned up to maximum heat! I also fitted a capacitor clip on the capacitor and secured it with a single nut and bolt through a hole drilled in the chassis – see photos.

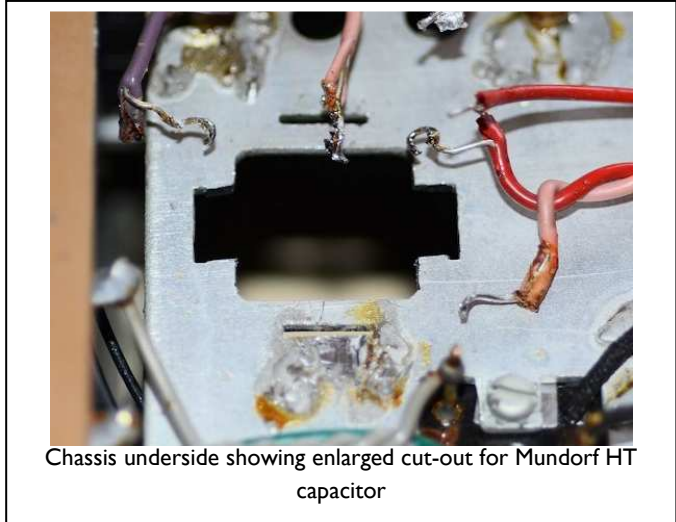
Chassis underside showing enlarged cut-out for Mundorf HT capacitor
